Titanic Research & Modeling Association

Murray's Boat Disengaging Gear

By Bob Read

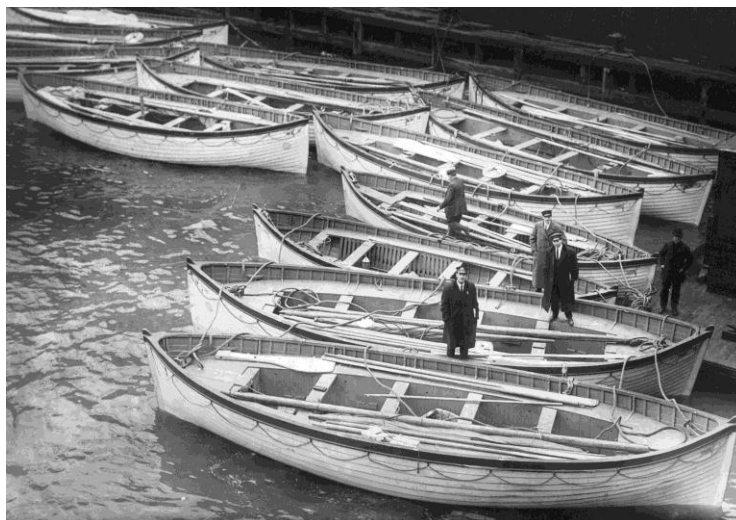
Figure 1

The few photos we have of the Murray's gear have had to be mined to discover most of what we know about the actual appearance of the device. The primary photo which has yielded the most information is a photo of Titanic's lifeboats post-disaster tied up at the dock in New York after they had been returned by R.M.S. Carpathia (Figure 1).

In examining enlarged areas of this photo, we find that there are some inconsistencies in the appearance of the devices. The inconsistencies are really apparent between the gear found on the 30 ft. main lifeboats and the 25 ft. emergency cutters. These differences will be discussed later. The next image is probably the best of the device as seen in a 30 ft. lifeboat (Figure 2).

One of the problems with the images in the master photo (Figure 1) is that there are other items of boat equipment which obstruct a clear view of the gear. The appearance of the gear in the 30 ft. boats appears relatively consistent. Where it can get confusing is with the 25 ft. emergency cutters. The appearance of the gear in these boats even varies from both forward to aft in these boats.

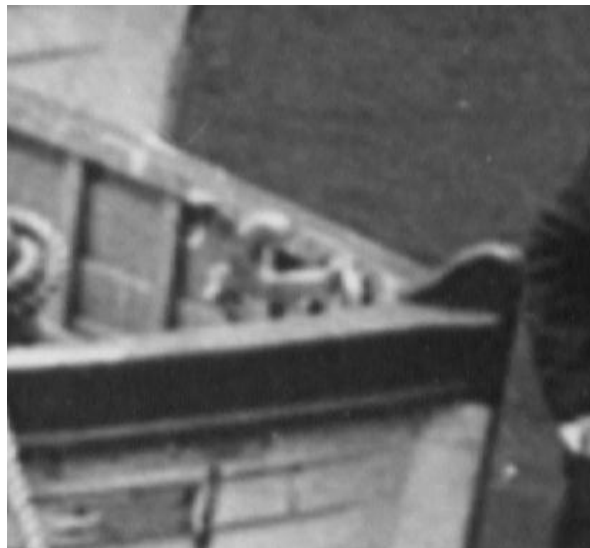
Figure 3

The next best photo example (Figure 3) is of the forward end of a 25 ft. emergency cutter. In this photo we see the disengaging hook rotated counterclockwise roughly 90 degrees from its locked position.

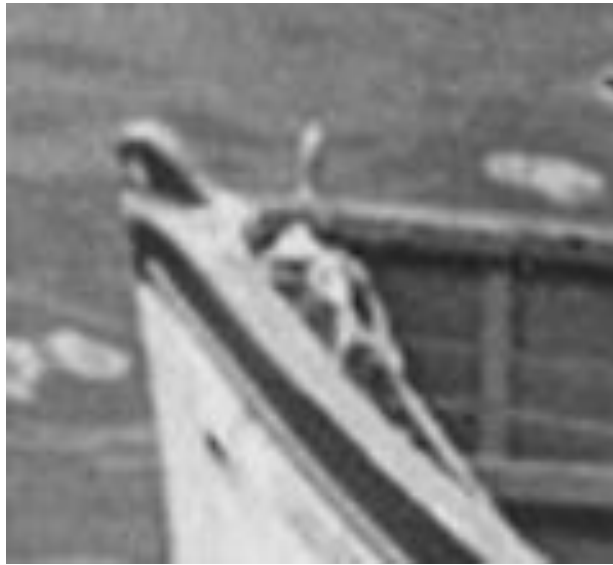
The next photo (Figure 4) is an enlargement of the area of the aft end of a 25 ft. emergency cutter. The fork in which the hook rotates is tilted toward the aft end of the boat and has a rod attached to the lower end of the fork. Some other piece of equipment appears to be obscuring the hook part of the gear. As will be explained later, in Figure 4 we do not see a board which ran fore and aft from the aftmost thwart to the aft end of the boat.

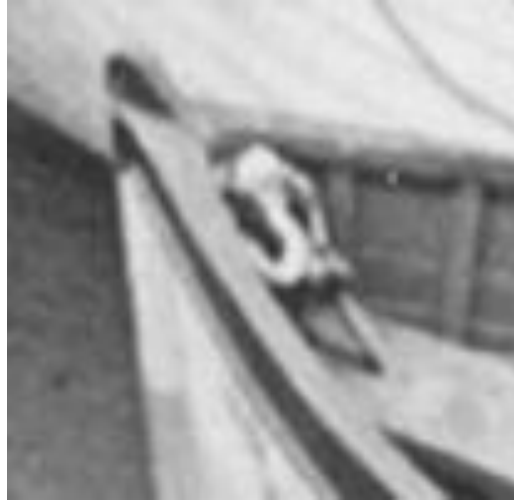
The next photo (Figure 5) shows the gear at the forward end of the 25 ft. boat. You can see the difficulty in discerning the structure of the gear at the angle of its tilt. What can be seen in this photo is that like the gear at the aft end of the boat, the gear appears to be angled toward the end of the boat. But at the forward end in Figure 5 there is a board through which the rod passes.

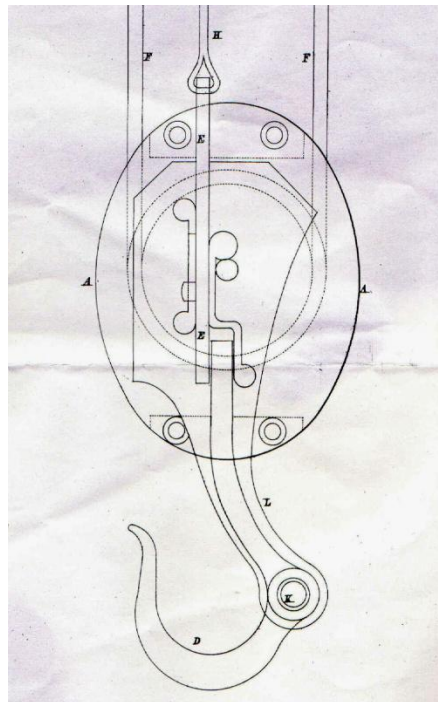
Figure 10 is a scan of Murray's original 1866 patent for boat disengaging gear. The main design difference is that the disengaging gear is an integral part of the lower fall block. This early design does have some elements which influenced the later design. The later design kept the rotating hook except that now the hook rotated on an axle between the tines of a fixed fork attached to the boat.

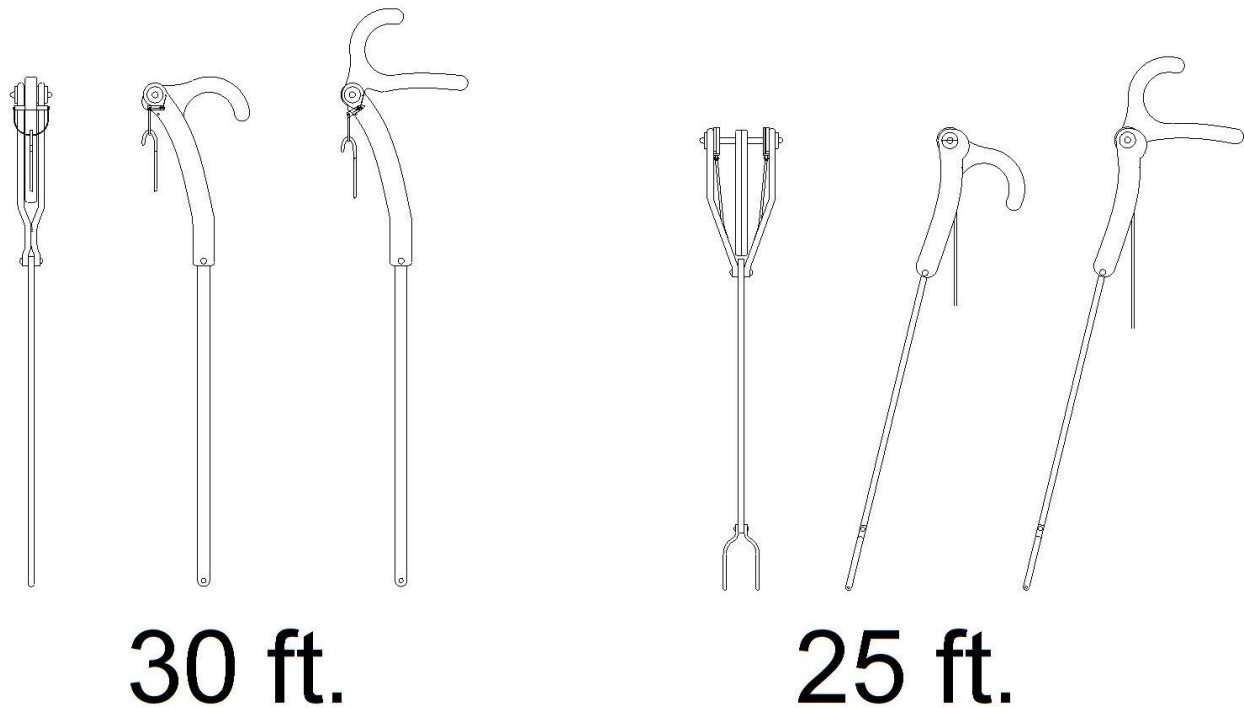
Figure 11 has a number of drawings showing the configuration of the disengaging gear for the 30 ft. and 25 ft. boats. There are both an end view and a lateral view in both drawings. These drawings show the gear in its locked position. The far right drawings show the gear released when the locking mechanism is pulled downward by the releasing hook which is attached to the releasing mechanism.

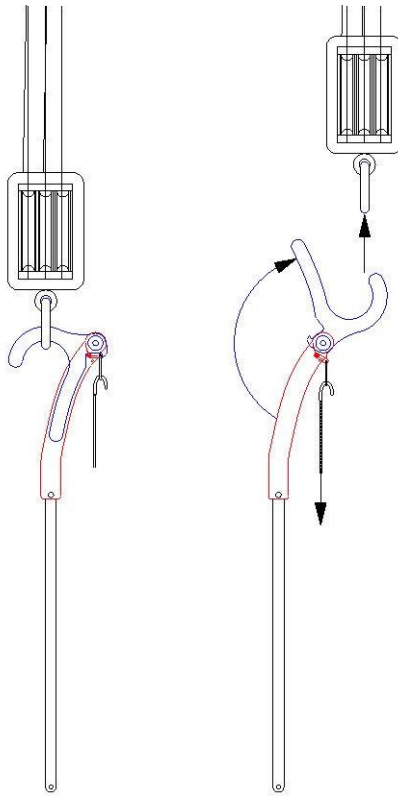
In Figure 12 we see an illustration of the release of the disengaging gear from the falls. The disengaging gear hook attaches to an eye at the bottom of the lower fall block. When the releasing mechanism's rod pulls down on the releasing hook attached to the latch mechanism, the disengaging hook is unlocked and released. It is able to rotate and release from the eye in the fall block which allows the boat to fall away from the falls and be free to maneuver.

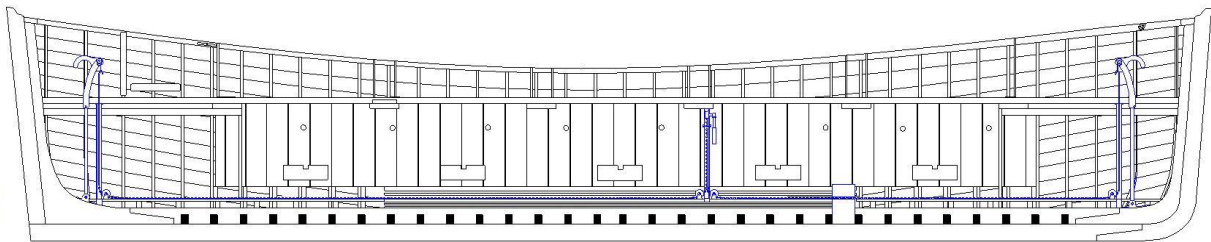
Figure 13 is a longitudinal cross section of a 30 ft. main lifeboat. The positions of the disengaging and releasing gear are shown in blue.

Figures 14, 15, and 16 are enlargements of the pertinent areas of figure 13. Figure 14 is the aft end of the boat. Figure 15 is the forward end of the boat. Figure 16 is the mid area of the boat showing the location of the releasing gear.

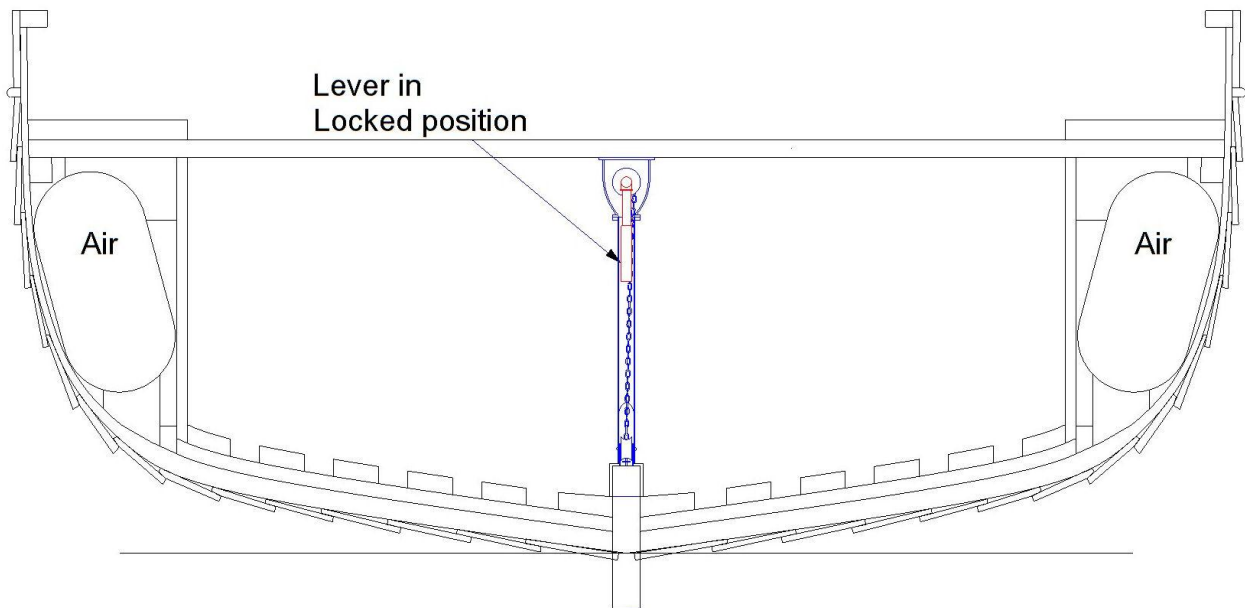
Figures 17 and 18 are cross sections across the breadth of the 30 ft. boat near the releasing lever. The positions for the locked and released positions are indicated. The lever was placed on the forward side of the thwart because those rowing would be facing aft. During rowing operations the lever would be behind the rower and would not interfere with the rowing function.

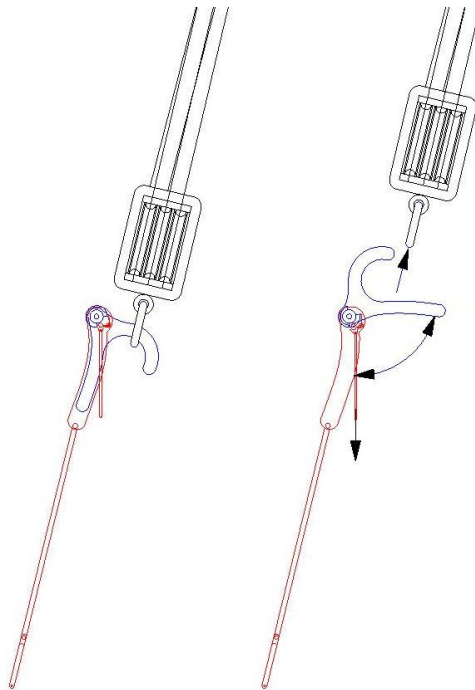
In the next series of drawings, the configuration of the alternate design of “Design B” of the Murrays device for the 25 ft. emergency cutters will be examined. In the Photos section, the existence and reason for a modification of the design of the gear for the 25 ft. boats was discussed. Figure 19 illustrates the operation of the gear for the 25 ft. boats. This gear is angled toward the ends of the boat. Its operation is similar to that of the gear for the 30 ft. boats as shown in figure 12 except that the pull on the gear is not straight upward as with the 30 ft. boats. Rather, the gear has to be angled to accommodate the davits which are spaced to accommodate the 30 ft. boats.

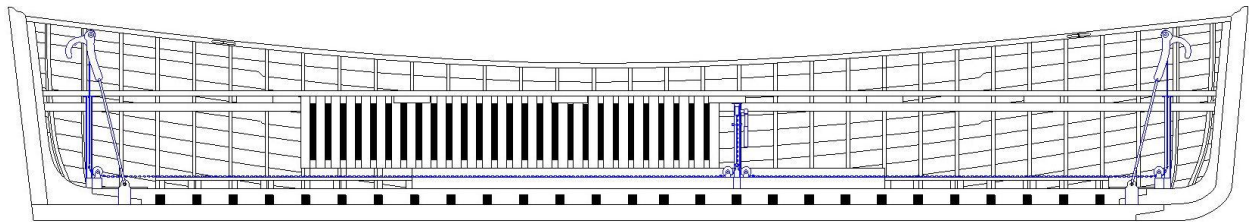
Figure 20 illustrates the gear for the 25 ft. boats in a longitudinal cross section.

Figures 22, 23, and 24 are enlargements of the pertinent areas of Figure 20. Figure 22 is the aft end of the boat. Figure 23 is the forward end of the boat. Figure 24 is the mid area of the boat showing the releasing lever.

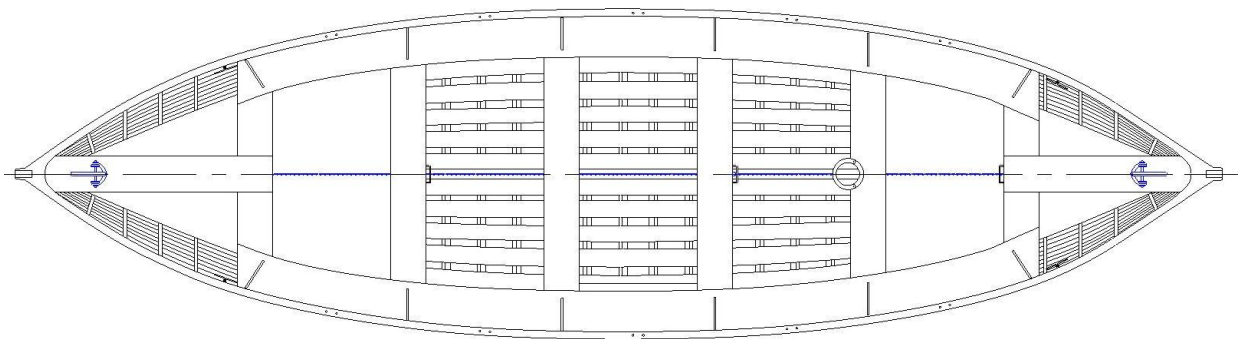
Figure 21 illustrates a plan view of one of the 25 ft. boats.

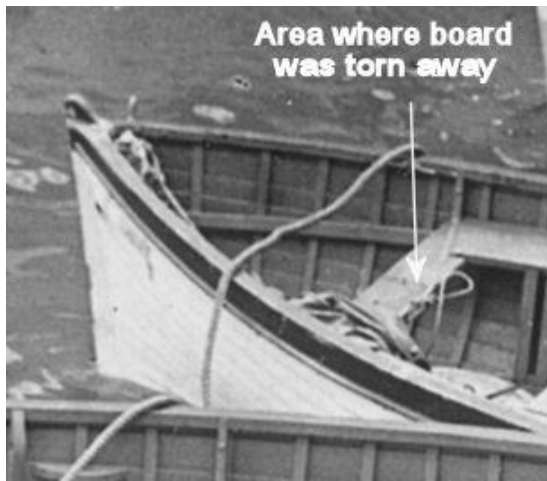
Recently an observation was made which helped explain some of the discrepancies seen in the 25 ft. boat disengaging gear. Figure 25 is an enlargement of the aft area of one of the 25 ft. boats. I have placed an arrow pointing to an area on the aft thwart which is a different color. What this indicates is where a fore and aft board attached to the aft thwart. Figure 26 shows the outline of where this board would have been before the board was torn away. The disengaging gear on the 25 ft. boats was angled to accommodate the spacing between Titanic's davits. Probably when this boat was being hoisted aboard R.M.S. Carpathia, the boat was being hoisted in such a manner that the force on the disengaging gear was vertical rather than at its

designed angle. This tended to lift the fore and aft board away from its fastening. After this board was gone, the disengaging gear now is not held in its designed position but falls toward the aft end of the boat as we see in the photo. This discrepancy hindered accurate interpretation of the set-up of the disengaging gear on the 25 ft. boats for some time.
